## Opel GT Headlight Rewiring Tips:

**ALL OPEL GT's NEED their headlights rewired!**

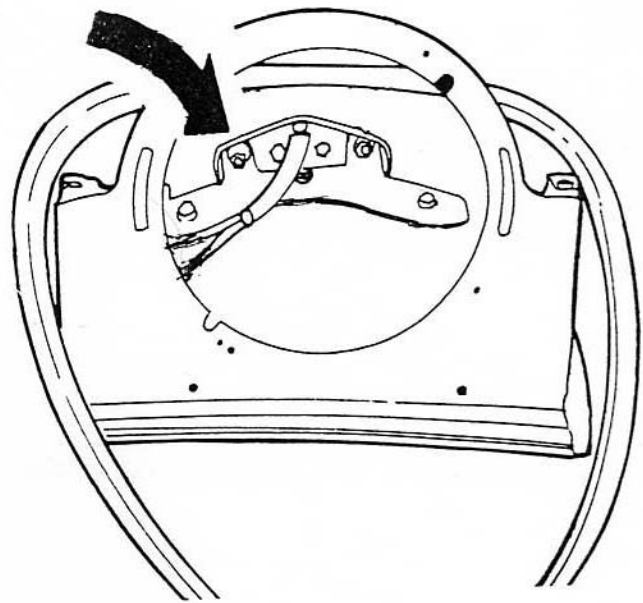
The area of most critical wear, is where the wire loom rotates behind the bulb; you can peel back some insulation here to view cracked rubber and bare wires. Additional symptoms may include: Failure of headlights, Failure of main (7-wire) headlight relay, and/or the amp gauge "pegging" when lights are switched on. (Refer to article for other GT headlight/micro-switch diagnoses).

Where to look for frayed headlight wires

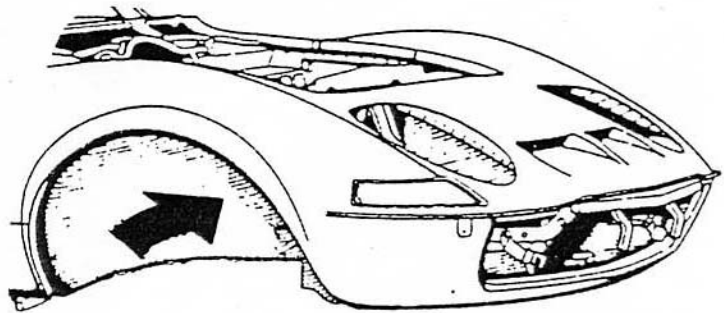
Where to locate access plate (passenger side shown)

Starting with the passenger "R" side: Inside front wheel-well, remove the 4 phillips-head screws holding the access plate (you have to scrape some undercoating off the heads of these 4 screws, to be able to turn them).

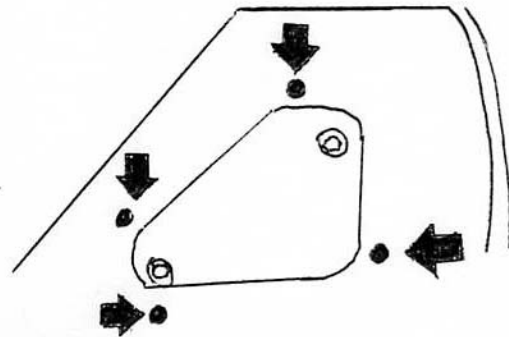
Access panel screw locations, Passenger side

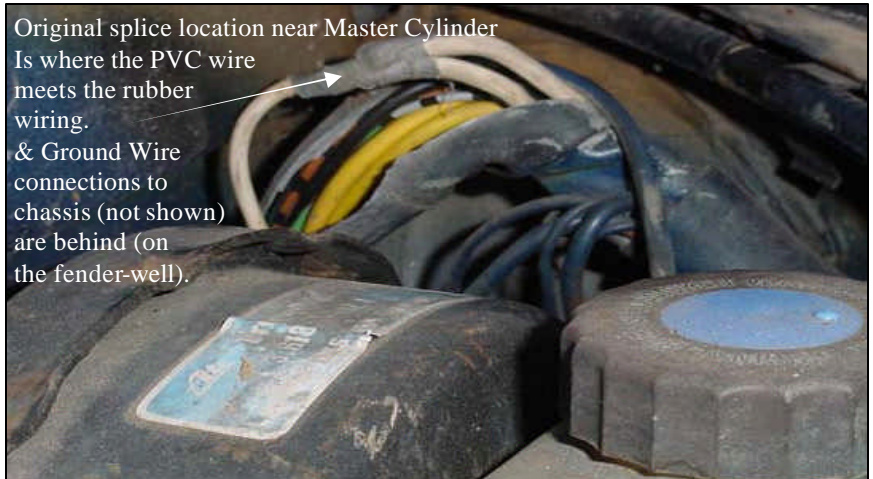
Original splice location near Master Cylinder  
Is where the PVC wire meets the rubber wiring.  
& Ground Wire connections to chassis (not shown) are behind (on the fender-well).

Separate brown (ground) wires from ends of the new wire looms near the Master Cylinder, then splice the yellow wire and the white wire to the existing wire harness. You have 2 options for location: The easiest to access, is on the main harness in the driver's side of the engine compartment, about 10" towards the rear from the radiator support beam. Unfurl the metal clips, then pull the main harness out from under the inner lip of the fender. The original splice location is near the master cylinder (where original wires connect 2-into-1 in the loom) but unless you insist on originality, it's a tight area for the splicing and soldering work.

Connect brown wires to chassis ground, by adding a round "eyelet" to wire ends and attaching with self-tapping screw to existing hole in engine area sheet metal (& sand off rust/paint there) on inner fender-well behind master cylinder (see photo).

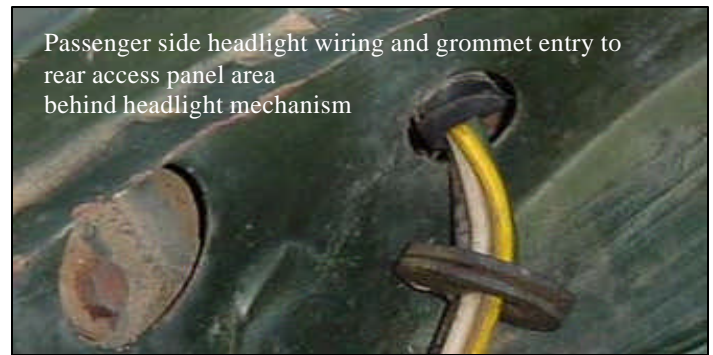
Passenger side headlight wiring and grommet entry to rear access panel area behind headlight mechanism

Carefully pull these wires back through the grommet into the under-hood area (It's a tight 15mm fit, so use some WD-40 or Vaseline to lube and protect the grommet and the tape on the new wire loom). Detach the ends of the new wires from the old wires, then cut into the old loom a couple of inches and cut off the old wires back in the old loom. Back at the headlight buckets, ensure that un-taped wire ends run through section of 15mm flex tubing in hole in headlight mechanism (to avoid chafing during rotation).

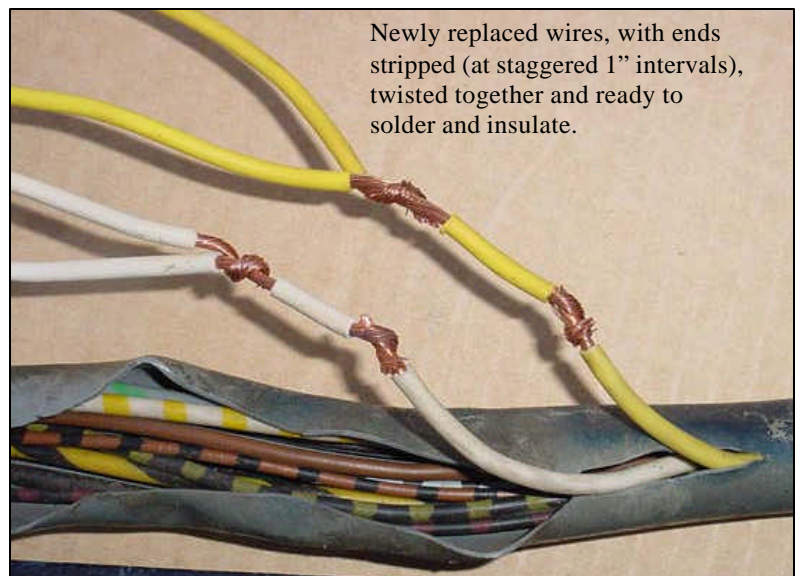
Newly replaced wires, with ends stripped (at staggered 1" intervals), twisted together and ready to solder and insulate.

Open up the loom, by cutting sleeve lengthwise about 8" with an exact-o blade, then locate, tug out and cut the white wire and yellow wire (forward of area to be spliced). Prepare to splice the ends of the replacement white wires to a small section of the original white wire (use blade to strip a 1" area of insulation, or two separate 1/2" areas "staggered" for a cleaner look). Place some cardboard below the area for protection, then carefully solder (using lots of flux) these wires together. Let cool, then use this same approach but about 1" back, to solder the replacement yellow wires to the original yellow wire. Let cool, then tape up the loom, and hide the splice area by securing it with the clips under the inner lip of the fender.

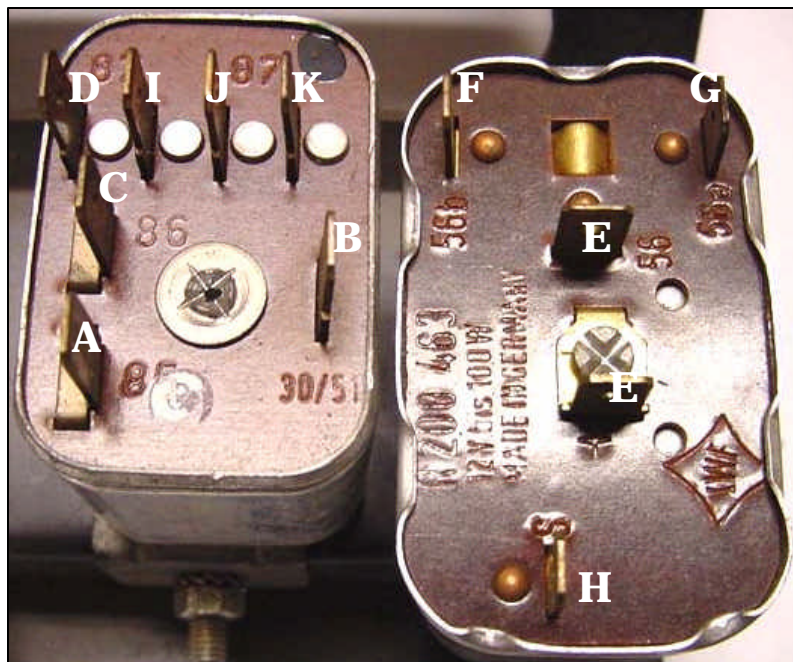
4) Test Microswitch operation. Test for power at "A." If there is no power there, and microswitch is receiving power (from black wire at fusebox terminal #2, same circuit as high beam dash-panel indicator lamp), then microswitch is inoperative.

5) Test for 7-Prong Relay operation. Test for power at "A" "B" and verify ground connection at "C." If these are OK, but there is no power output at "D" then the relay is burnt internally and has failed. This is the main GT Headlight Relay, most commonly affected by short-circuits from cracked insulation on headlight wires. A replacement relay is available from Opel retailers.

6) Test for 5-Prong Relay operation. If there is power at "E" but there is no power at BOTH "F" and "G" (only one operates at a time), then the relay has failed. This is the "High Beam" relay.

7) Test Switch between High and Low Beam Circuit. Briefly touch "H" to ground. If output of 5-prong relay doesn't switch between low "F" and high "G" beams, then relay is bad. (This test can only be performed when "E" is receiving 12 volts from main 7-prong headlight relay).

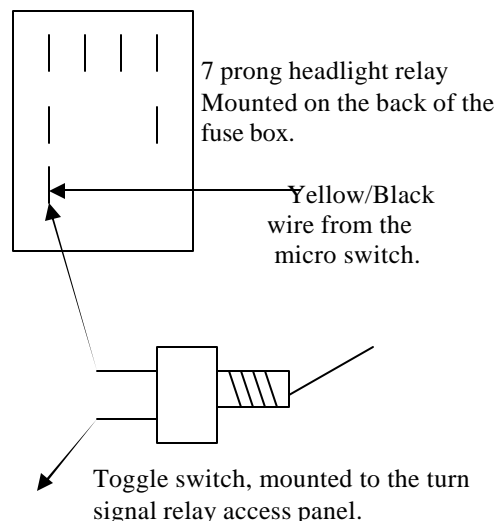
To the fuse box, #2 fuse  
Add to the black wire connection.

**An alternative to the difficult job of pulling the driver's side headlight mechanism -- required to replace the micro-switch on 1970-1973 GT's -- is to add a substitute "toggle switch" to turn the headlights on and off. See Diagram, below right.**
